Roller Testing to Mimic Damage of the ISS SARJ Ring and Durability Test to Simulate 15 Years of SARJ Operation Using the Damaged Surface

*Timothy L. Krantz, Justin P. Elchert, Christopher DellaCorte, and Michael J. Dube
Glenn Research Center, Cleveland, Ohio*

Glenn Research Center
Cleveland, Ohio 44135

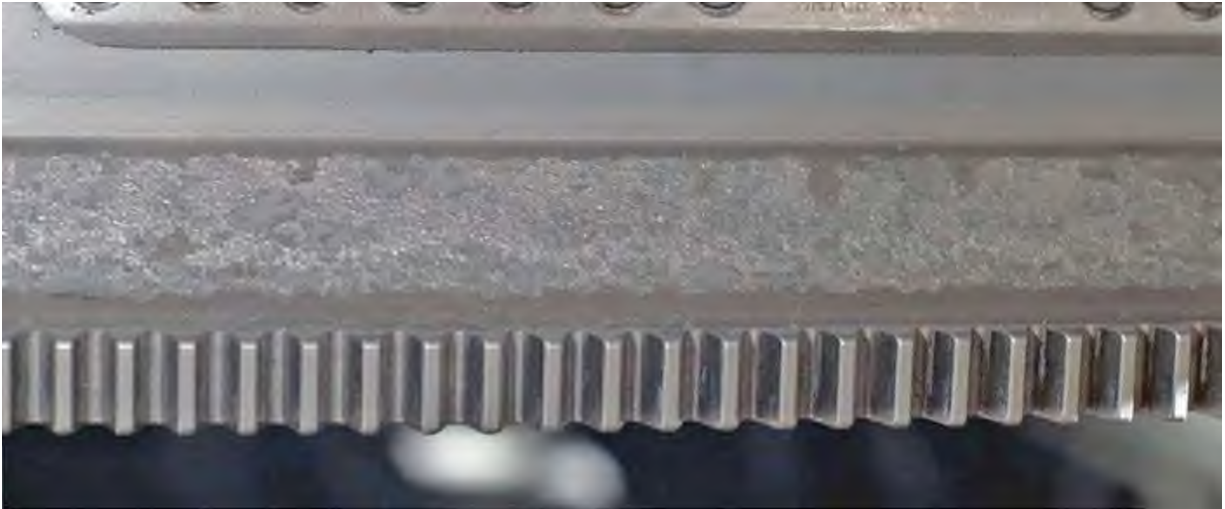
Figure 1.—Damaged surface of a SARJ ring.

The International Space Station (ISS) makes use of a roller-based mechanism for positioning of the solar arrays. The fundamental concept of the roller-based mechanism of the ISS Solar Alpha Rotary Joint (SARJ) is described by Loewenthal and Schuller (Ref. 1). The starboard SARJ was launched in 2007 and began operation late in the year. After 16 days of operation, the drive torque and vibration began to rise. In late 2007 and early 2008, Extra Vehicular Activities (EVA) were conducted to inspect the starboard mechanism to determine the reasons for its poor performance. During the first such EVA, metallic wear debris was detected. Further inspections following continued use of the SARJ showed widespread wear debris and damage to one of the primary contact surfaces. A photograph of the damage to the SARJ ring is provided in Figure 1. The roughened surface shown in the figure is the mating surface for a set of rollers. The damaged surface is 15-5 steel that was provided with a nitrided treatment. The nitrided layer was applied with intended depth of about 0.15 mm (0.007 in.). Some of the debris has been returned to earth and analyzed. The debris has been determined to be primarily nitrided 15-5 PH steel (Ref. 2). The breakup of the race ring has been at least partially attributed to inadequate lubrication of the race ring and the contacting rollers (Ref. 2). Late in 2008 the starboard SARJ mechanism was cleaned and lubricated with grease.

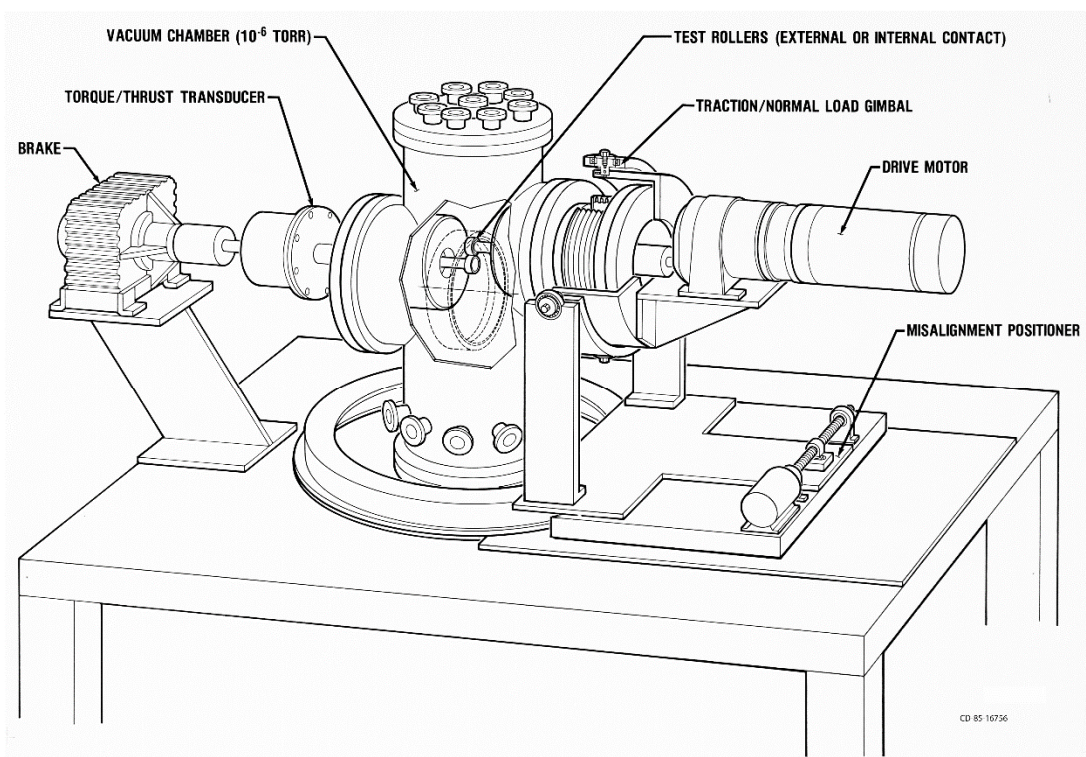
Figure 2.—Vacuum roller rig.

Testing was done using the NASA Glenn Research Center's Vacuum Roller Rig (Fig. 2). The rig allows for application and measurement of a load pressing the rollers together while having a purposely misaligned and adjustable shaft angle. The rig is depicted in schematic form in Figure 3. A drive motor provides motion to the driving roller. A magnetic-particle brake attached to the output shaft imposes torque on the driven roller. The rig can be operated with the brake not energized. For such a condition the torque transmitted through the roller pair is only the drag torque of the output shaft (drag of the seals and support bearings). The normal load pressing the rollers together is provided by an air cylinder. The cylinder acts through a gimbal point to rotate the plate that mounts the driving shaft and drive motor. The rotation of the drive motor plate displaces the driving roller toward the driven roller shaft. The pressure to the cylinder, and thereby the load between the contacting rollers, is adjusted by a hand-operated valve (open-loop control). Testing can be done in vacuum or ambient air. Vacuum is provided by a diffusion pump with a liquid nitrogen cold trap. The diffusion pump is assisted by a mechanical vacuum pump. Figure 4 provides a simplified schematic labeled with some of the nomenclature used herein.

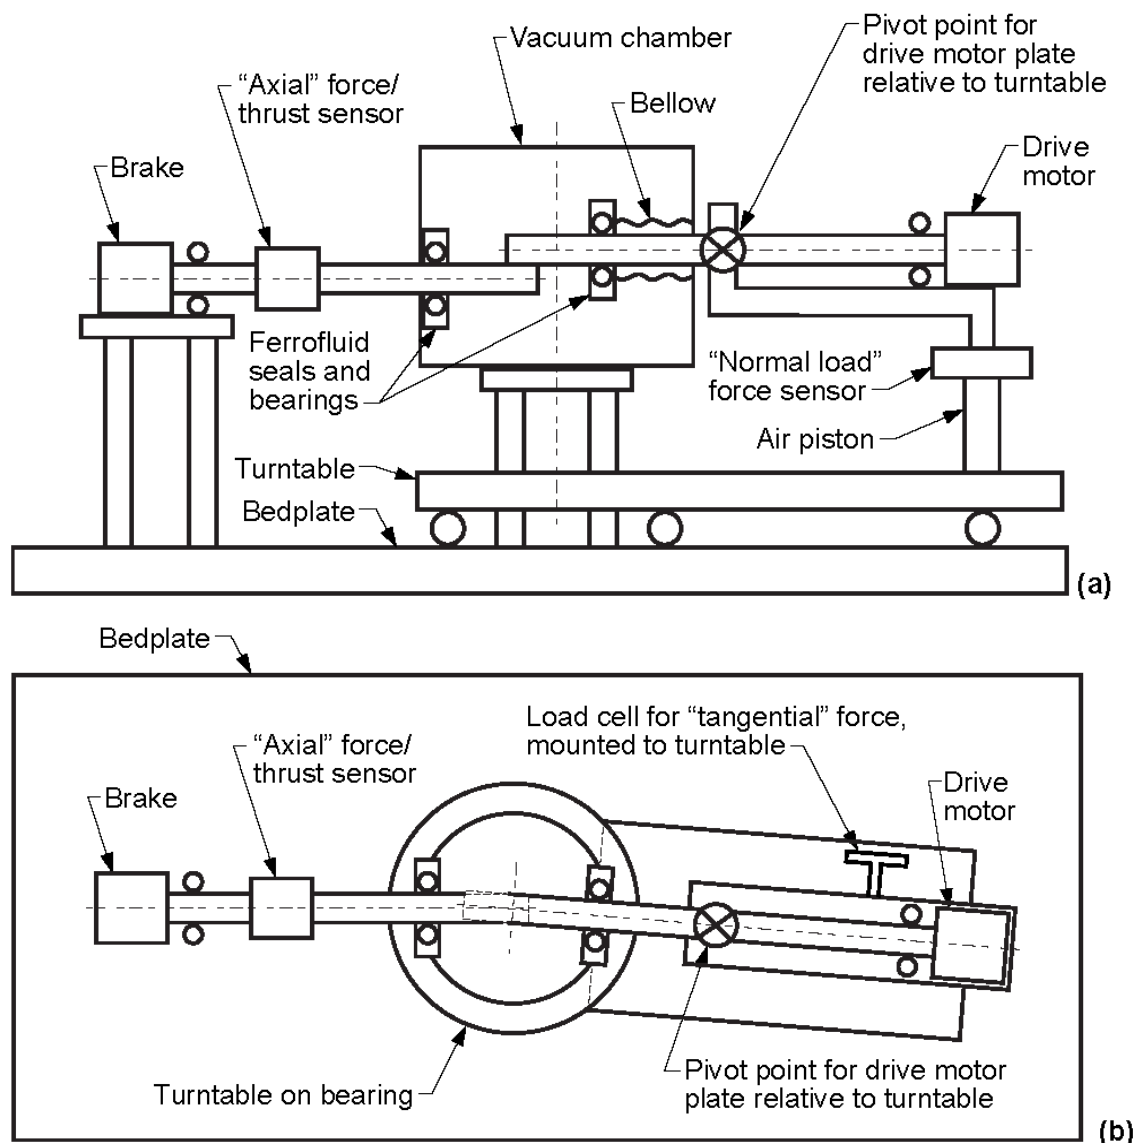
Figure 3.—Schematic views of the vacuum roller rig. (a) Schematic, side view. (b) Schematic, overhead view with shaft misalignment depicted and exaggerated.

Next we will discuss the selection of the misalignment angle of the test rollers. The misalignment is depicted in exaggerated manner in Figure 3. Deviation from perfect alignment of the roller axes causes the development of surface tractions (Ref. 5). The surface tractions occur since points in direct contact can be held together by contact friction and, thereby, deviate from the motion that would be occur if the roller was unconstrained by its mate. The deviation from free, unconstrained motion creates strains in the materials in contact. The contact region features both “stick and “slip” regions (Ref. 5). The magnitudes of the traction forces depend on the lubrication (friction) condition that thereby defines the transition from a stick to slip region. To a first order approximation, an approach to relate the SARJ misalignment angle and the test rig misalignment angle is to match the product of the contact region in the direction of rolling times the misalignment angle for both systems. Such an approach will provide for similar regions of sticking and slipping in terms of absolute distance. From Figures 18 and 19, we see that the maximum

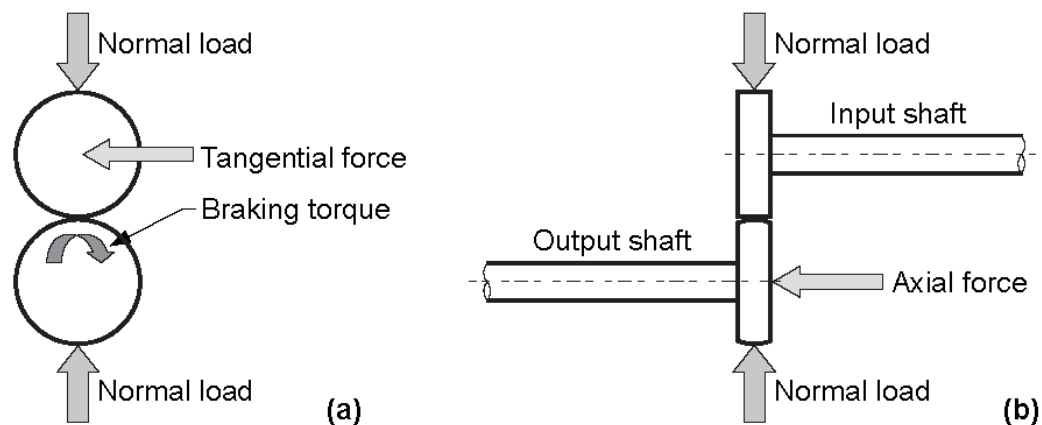
Figure 4.—Simplified schematic view including some of the important sensed data. (a) Schematic, front view. (b) Schematic, side view.

The load that presses the rollers together is termed herein the “normal load” (Fig. 4). The normal load is applied via an air-pressure actuated piston. The air piston acts through a load cell against the drive motor plate that is gimbal-mounted relative to the test chamber (Fig. 3(a)). In this way the air cylinder moves the roller on the input shaft in an arc motion toward the test roller. Once the rollers are in contact, additional force commanded from the air cylinder increases the normal load between the test rollers. The force sensed by the load cell located between the gimballed motor plate and the air piston is a linear combination of two sources, the unbalanced mass relative to the gimbal point and the normal load on the test roller.

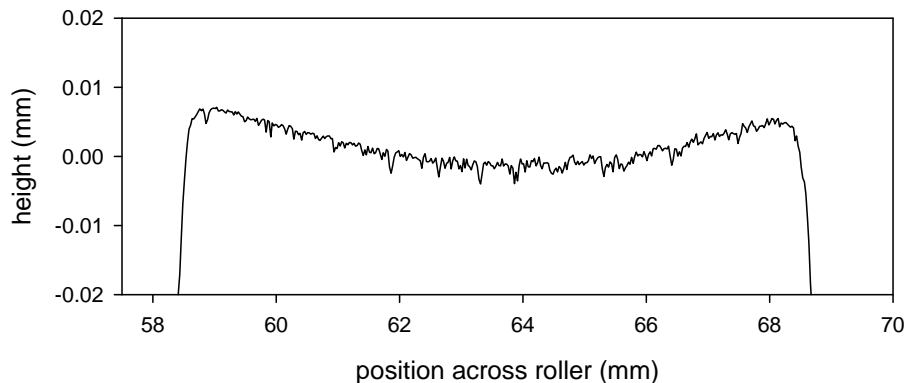
Figure 5.—Measured form of the nitrided 15-5 test roller in the direction of the roller width.

The manufactured geometries of the test rollers were inspected using a profilometer with a 2 μm radius conisphere tip stylus. To provide a controlled contact condition on the test apparatus, at least one of the two rollers must be crowned across the roller width. The 15-5 roller profile was designed as nominally flat, and the measured profile was found to be slightly concave (Fig. 5). The deviation in form from a flat profile was approximately 10 μm . The measured roughness of the nitrided roller in the direction of rolling is provided in Figure 6. Rollers made from 440C to mate with the nitride roller had differing form profiles for the initiation and propagation/durability phases of the testing. The SARJ rollers have a nominally flat profile with 45° angled chamfered ends with a blend radius transition from the flat region to the chamfered region. The 440C test roller used for damage initiation had geometry to mimic the blend radius used on the SARJ rollers. A cross-section view and measured roller profile for the specialized “blend-radius” roller are provided in Figure 7. The radius at the top of the roller per measurement was 1.5 mm. The 440C rollers used for damage propagation and durability testing had circular-crowned profiles across the roller of about 81 μm . The measured crown profile is provided in Figure 8. The roughness in the direction of rolling of the 440C roller used for durability testing is provided in Figure 9. Note the scaling of the ordinates when comparing to the roughness of the nitrided roller of Figure 6.

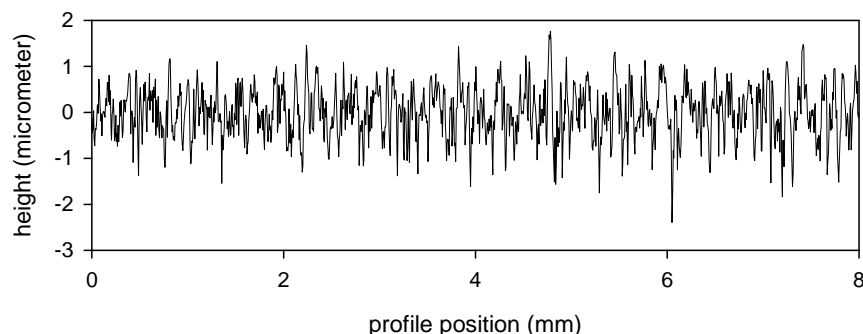
Figure 6.—Roughness of nitrided roller in the direction of rolling.

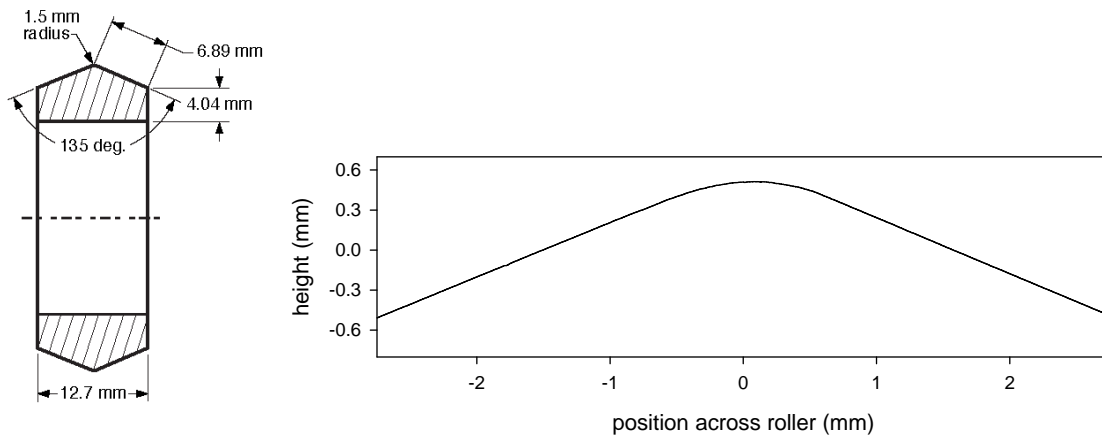
Figure 7.—Cross section view of roller design and the measured shape of the crown radius of the 440C “blend-radius” roller used for damage initiation.

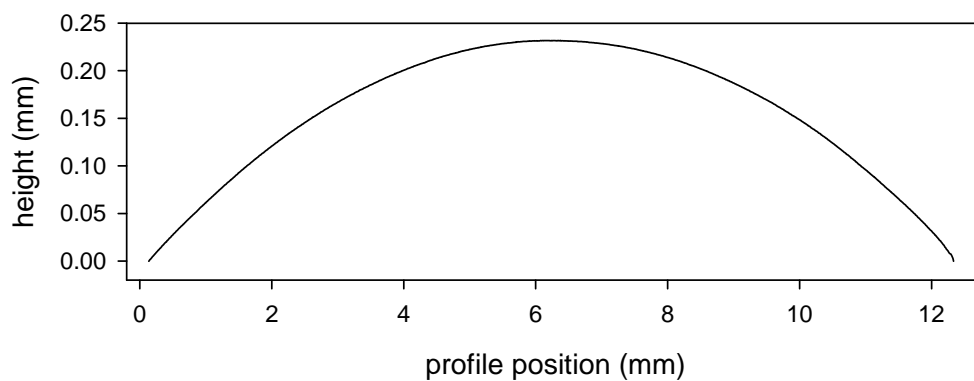
Figure 8.—Cross-section profile of 440C roller used for damage propagation and durability testing having crown radius of approximately 81 mm.

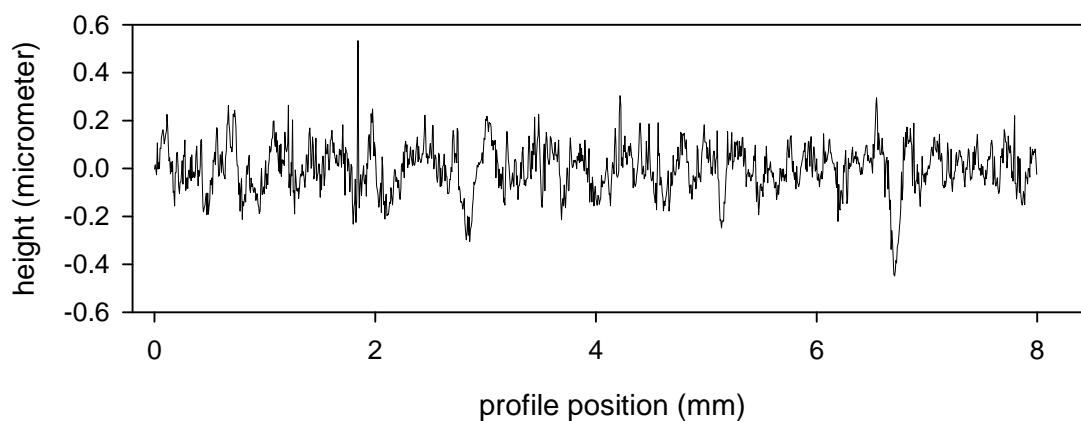
Figure 9.—Roughness of 440C roller used for damage propagation and durability testing.

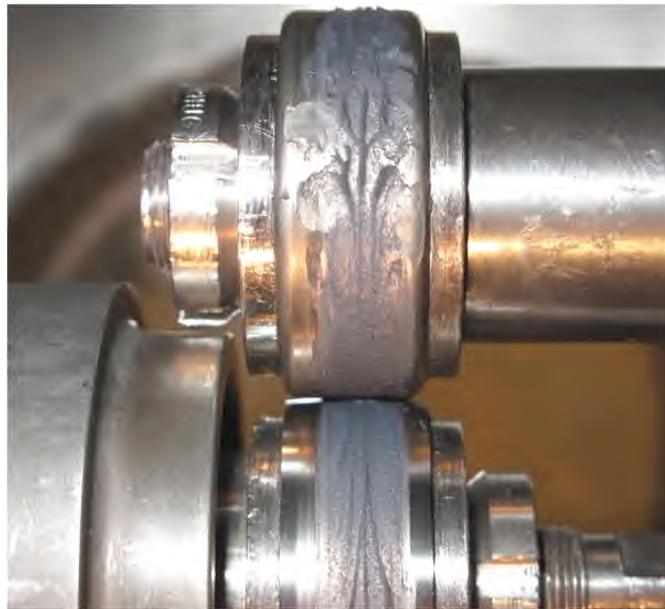
Figure 10.—Test rollers with grease applied and distributed to prepare for durability testing.

For the durability phase of testing, rollers were lubricated using a space-qualified grease. The base oil of the grease is a stable perfluorinated polyether. The gelling agent is a tetrafluoroethylene telomer. The grease contains molybdenum disulfide. The grease was applied using a syringe. The difference in the mass of the syringe before and after applying the grease was recorded and was typically about 0.2 grams. The grease was distributed on the rollers by positioning the rollers with only a small gap between them and the shafts were rotated. As the grease became distributed by the shaft rotation the gap between the rollers was slowly reduced in increments. This action proved effective to distribute the grease about the roller circumference, and by visual inspection the distribution of the grease about the roller circumference appeared uniform (Fig. 10). As needed, the rollers were removed from the test apparatus for detailed inspection. In such cases, the grease was removed from the rollers using soft cloths for the inspections, and then grease was re-applied for the next increment of durability testing.

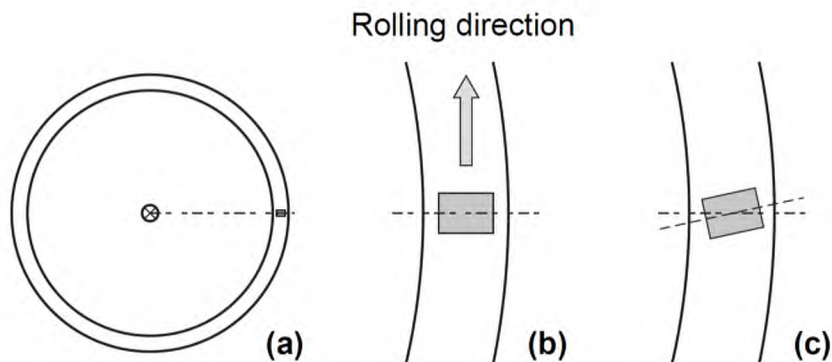
Figure 11.—SARJ ring and roller schematic, top view. (a) Overall view, roller axis aligned with ring axis; (b) overhead, close-up view near roller, aligned axis; (c) close-up view near roller, roller axis misaligned (misalignment magnitude greatly exaggerated).

To understand the loading conditions on SARJ mechanism rollers one needs to consider the influence of forces arising from misalignment of the rollers relative to the SARJ ring. Figure 11 illustrates the meaning of shaft misalignment. Kalker conducted pioneering research on the forces and moments that can arise from rollers in a variety of contact conditions (Ref. 5). The ground vehicle community has studied this phenomena for engineering of tires (Ref. 6). The SARJ rollers are constrained to rotate about shaft axes that nominally intersect the rotational axis of the ring (Fig. 11(a) and (b)). Any deviation from perfect alignment of a roller axis and ring axis (Fig. 11(c)) will give rise to a force at the contact interface in the direction of the roller shaft axis (termed herein the axial force). The magnitude of the axial force will depend on the magnitude of misalignment, the normal load on the roller, the stiffness of the system, the torque transmitted by the roller, and frictional condition of the contacting surfaces. The SARJ mechanism was built to high precision, and the installed roller shaft angle (misalignment) was within a fraction of a degree to perfect alignment. Still, misalignments of even such small magnitude can produce significant forces that influence the performance of the mechanism.

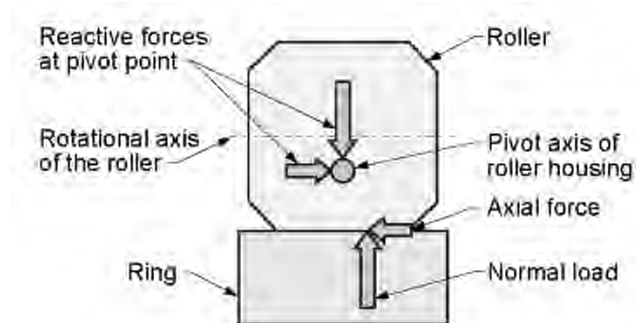
Figure 12.—Schematic of the SARJ roller and ring in contact, front view in cross-section.

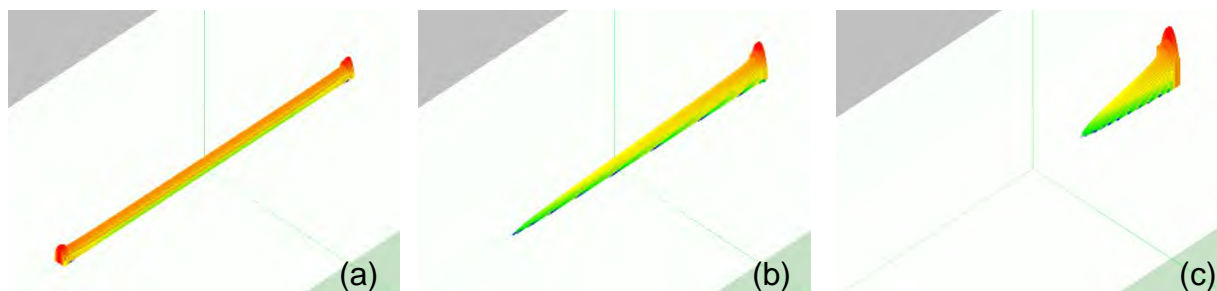
Figure 13.—Results of contact analysis of SARJ roller having the same normal load and three differing levels of axial load. (a) zero axial load, (b) axial load 0.18 times the normal load, (c) axial load 0.30 times the normal load.

A contact analysis computer program based on the method discussed by Vijayakar (Ref. 7) was used to study the influence of the misaligned axis on the resultant roller-ring contact pressure. This analysis was done assuming that the pivot point in the roller housing provided negligible resistance to the overturning moment (some small resistance might be possible depending on the friction condition at the pivot point). Analysis results depicting contact pressures for three different values of overturning moment, as would result from three levels of axial force axial, are provided in Figure 13. Figure 13(a) shows the contact pressure produced by the roller on the ring for the idealized case of zero axial load as would happen for perfect alignment of the roller shaft and/or frictionless surfaces. The contact pressure is even across the width of the flat portion of the roller except for some pressure concentration at the location of the blend radius transitioning to the chamfer geometry. Figure 13(b) shows the contact pressure for the case of an axial load 0.18 times the normal load, as would occur for well-lubricated surfaces. Contact pressure is relieved from the left edge and concentrated at the blend-radius location toward the right edge. The shifting of the contact pressure is not too dramatic. Figure 13(c) shows the contact pressure for the case of axial load 0.30 times the normal load, as might represent marginal

lubrication (but not dry) condition. In this case, the contact pressure is concentrated over less than 1/3 of the available roller length, and the pressure carried in the region of the blend-radius is significant. In this case, the rigid body rotation of the roller was calculated to be about 0.2° of rotation, denoting a very slight tipping of the roller about the housing pivot point. Note that in the three plots of Figure 13, the contact pressures are scaled the same in each plot and so the plots can be compared to assess the relative pressure magnitudes. As is evident from these analyses results, the larger the axial force the larger is the fraction of the total contact pressure imposed on the blend radius region of the SARJ roller.

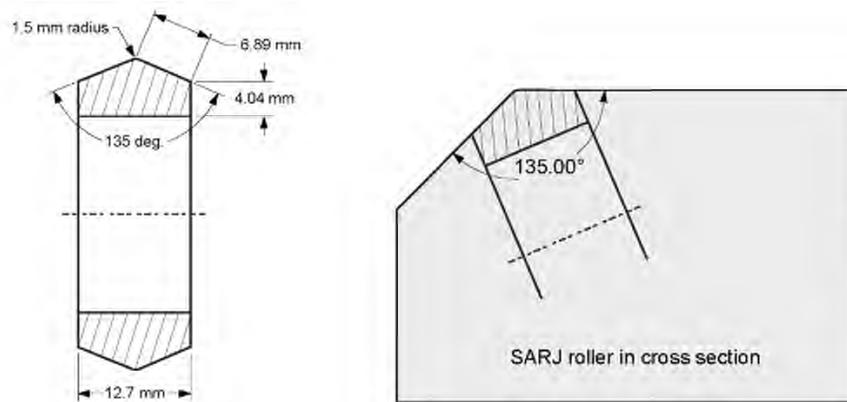
Figure 14.—Cross section of the “blend radius” roller and overlay of the roller shape on the SARJ roller cross section in the chamfer radius region.

The Vacuum Roller Rig (VRR) used for this laboratory experiment does not include the degree-of-freedom provided by the pivot point in the SARJ mechanism housing. While in the SARJ mechanism the overturning moment created by the axial force is balanced by the shifting of the contact pressure (per Fig. 13), in the VRR the overturning moment is reacted directly by the shaft support bearings. To be able to simulate the effect of the contact pressure carried by the small blend radius of the SARJ roller, a special “blend-radius roller” was created for the VRR. The concept for the roller geometry is depicted in Figure 14. By employing this special roller, the VRR could be used to simulate the condition of a slightly tipped SARJ roller even though the tipping degree of freedom is not present in the VRR. A photo of the blend radius roller in the VRR is provided in Figure 15.

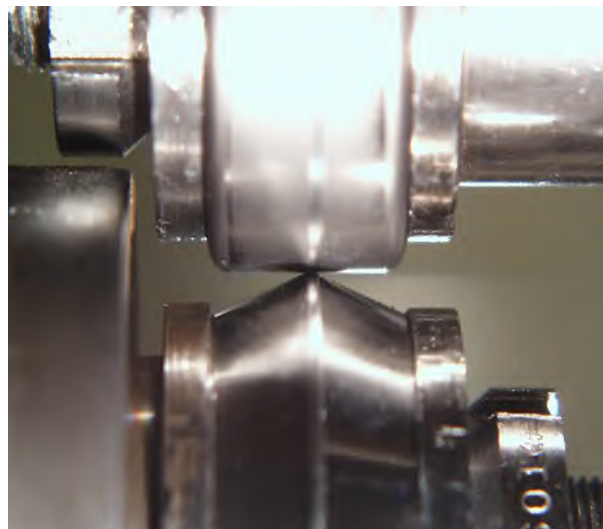
Figure 15.—Photograph of the 440C blend radius roller on the lower shaft engaging a nitrided 15-5 roller on the upper shaft, simulating contact pressure concentration of chamfer blend radius on a SARJ roller.

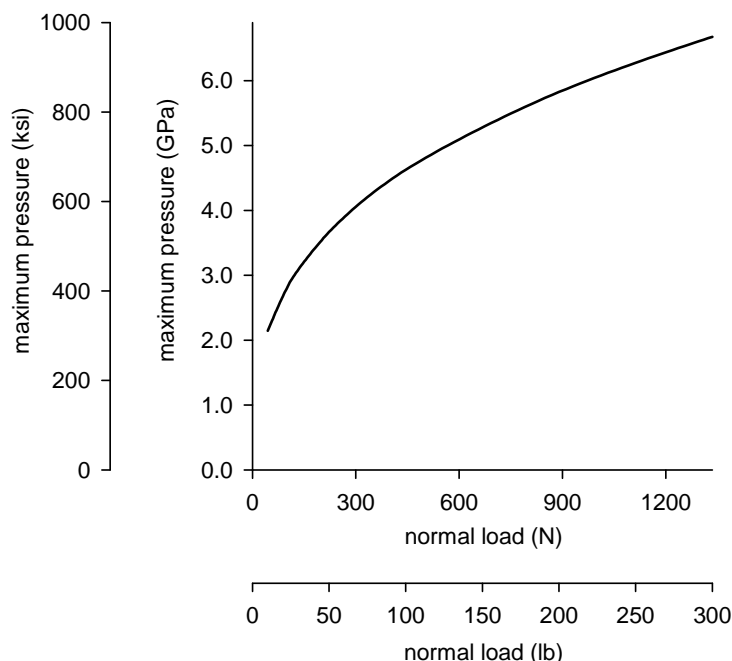
Figure 16.—Maximum Hertzian contact pressures obtained using the blend radius roller of Figures 14 and 15 for a range of normal loads assuming elastic response.

used for damage initiation (Fig. 16). The test conditions for the damage propagation testing included no lubrication, a shaft misalignment angle of -0.7° , speed of 18 rev/min., and a normal load of about 900 N. These conditions were selected primarily by practical testing considerations. The testing duration to achieve damage propagation was a real-time judgment based on the visual appearance of the 15-5 roller surface as the damage progressed with the intent to replicate as close as possible the level of damage on the SARJ ring per EVA photographs.

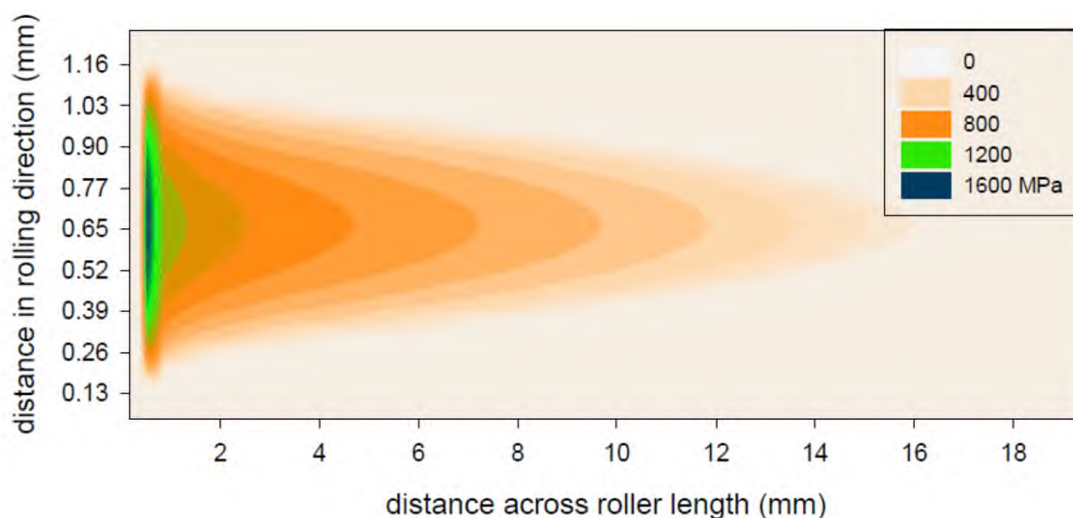
Figure 18.—Contour plot of calculated pressure distribution for SARJ roller and raceway operating with a 4500 N normal load and 800 N axial load.

Next we will discuss the selection of the test load applied to press the test rollers together (denoted as the normal load in Fig. 4). Keeping in mind the primary goal of the test was to assess the durability of the SARJ ring, the testing load was selected to mimic the contact pressure on the SARJ ring when a given region of the rotating ring passes under a roller. The contact region of the test rig and the SARJ mechanism differ because of the differing geometries and kinematic constraints. For the test rig the contact region is an ellipse shape while for the SARJ mechanism the contact region has an elongated triangular shape. Each roller on the SARJ mechanism can provide a slightly different contact pressure distribution depending on the normal load on the roller, the misalignment angle, and the lubrication condition of the ring-roller contact. The VRR test rig in its existing configuration does not allow for automated adjustment of load, and so a constant-load test was needed devised. We selected to mimic the contact pressure of a SARJ roller having a 4.5 kN (1000 lb) normal load and an axial load of 0.80 kN (180 lb). The axial load produces a net moment because of the camber degree of freedom in the roller housing, and so the pressure distribution features a shifting of the pressure toward the roller edge to create the balancing moment. The axial load/normal load ratio of 0.18 is a realistic value assuming good lubrication and a realistic value of roller misalignment of 0.35° . A contact analysis was completed for this loading of the SARJ roller-raceway in contact using software based on methods of Vijayakar (Ref. 7). The resulting pressure distribution as a contour map is provided in Figure 18. The maximum and mean pressures for the distribution of Figure 18 are 1600 MPa (230,000 psi) maximum and 470 MPa

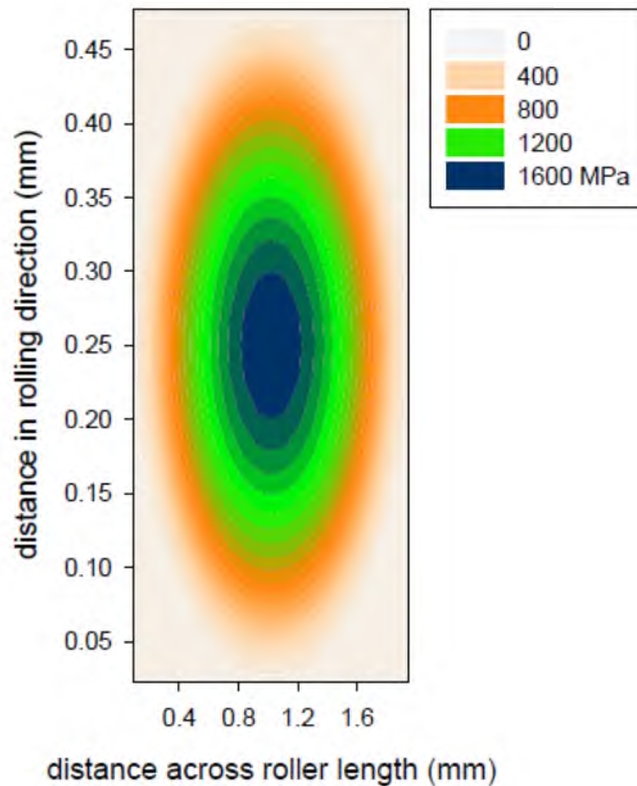
Figure 19.—Contour plot of calculated pressure distribution for vacuum roller rig operating with a 780 N normal load.

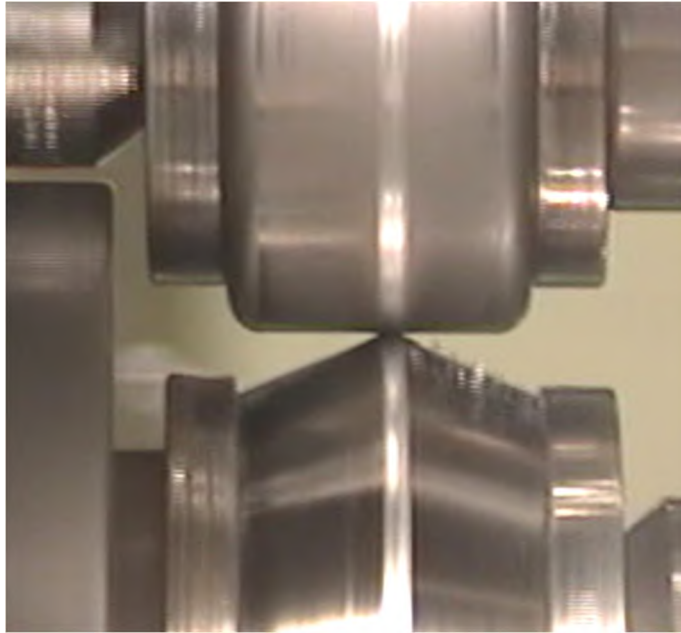
Figure 20.—Needle-shaped debris on the right side of the 440C roller (lower roller) as recorded during load step #5 of the damage initiation testing.

During load step #5 of Table 1, more debris was generated including some needle-shaped debris that stood on end from the 440C roller surface. In Figure 20, a frame from the digital video recording, although somewhat out of focus because of the frame rate, shows the appearance of debris during load step #5. Similar debris of significant volume has been documented in photos of a trundle bearing assembly used on the damaged SARJ mechanism (Fig. 21).

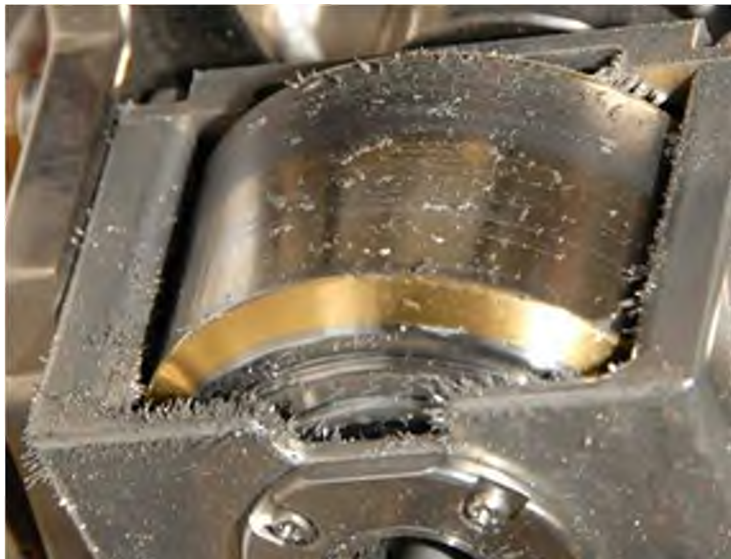
Figure 21.—Copious debris, including some needle-shaped debris, on a trundle bearing assembly that was mated with the damaged SARJ ring and returned from orbit for inspections.

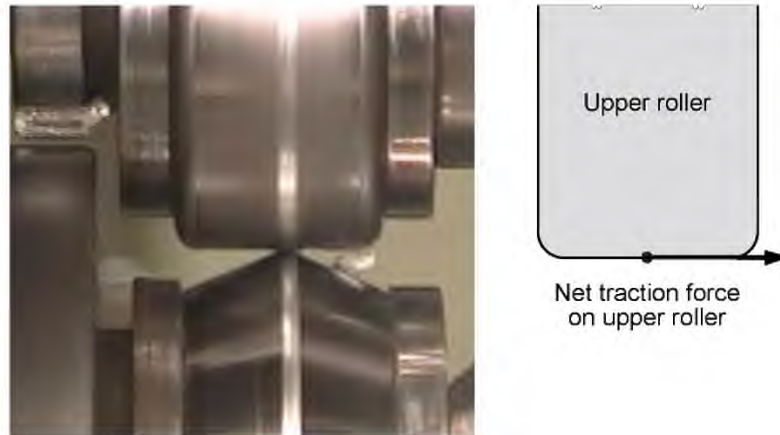
Figure 22.—Chip generating event captured on digital video. The chip is being liberated from the upper roller. The schematic shows the location and direction of the net axial force from traction on the upper roller.

During the transition from load step #5 to load step #6, a dramatic failure of the surface of the nitrided (upper) roller occurred and a large chip was liberated. Figure 22 is an image from the video recording showing the chip about to be liberated from the surface. The location of the chipped region included the zone adjacent to but outside of the immediate contact region reaching to the edge of the roller. Soon after the chipping event was noted, the rig speed was reduced so that the video could capture images of the chipped surface and additional damage propagation. After 245 shaft revolutions subsequent to the chipping event the test was stopped. Figure 22 has been augmented with a schematic showing the direction of the traction force imposed on the upper roller by the lower roller. Note that such a traction force will cause the nitrided layer to be in compression in the region where the chip was liberated. The measured axially directed traction force ranged from 434 to 512 N during the transition from load step #5 to load step #6 when the chipping failure occurred.

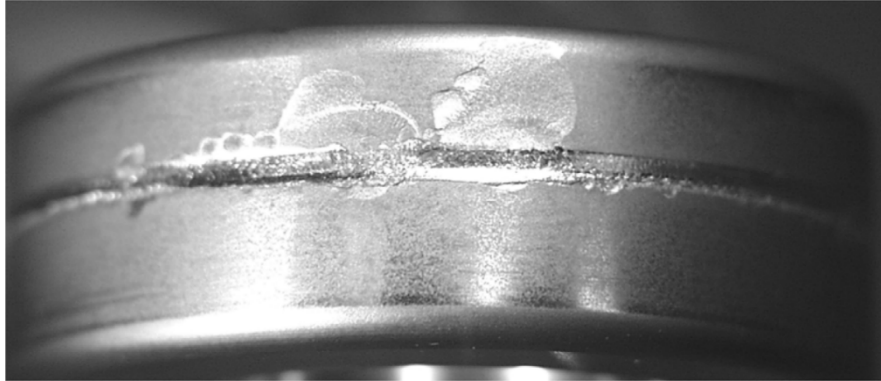
Figure 23.—Condition of the nitrided roller at the end of the damage initiation test. The circumferential location is the region where the large chip of Figure 22 was liberated.

The visual appearance of the damage at the end of initiation testing is documented in Figures 23 and 24. Figure 23 shows the region where the large chip was liberated. Additional chipping outside of the narrow contact region is evident on both sides of the wear track. Figure 24 shows the region approximately one-half of a rotation around the circumference from the previous figure. Damage has occurred both within and adjacent to the wear track. The after-test condition of the mating 440C roller with the blend-radius geometry is provided in Figure 25. From this macroscopic view, it appears that there has been little change to this roller except for some minor wear and plastic deformation of asperity features.

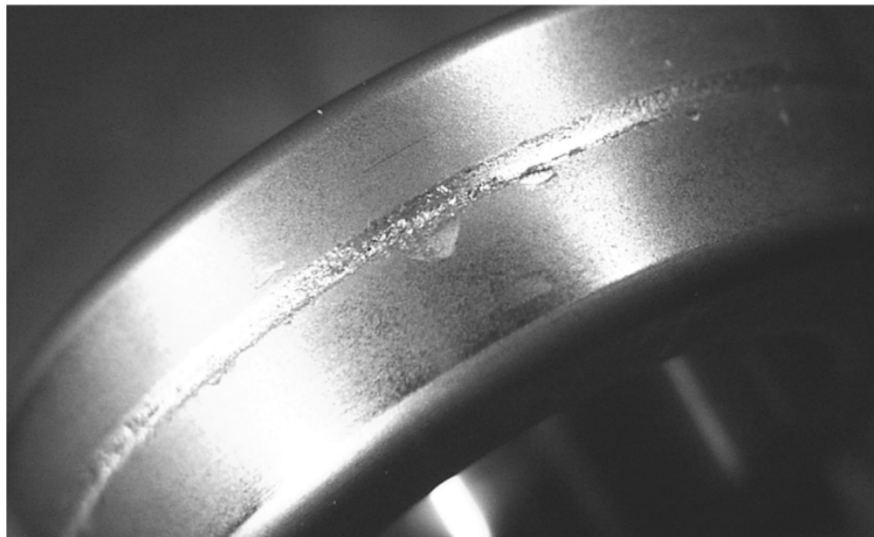
Figure 24.—Condition of the nitrided roller at the end of the damage initiation test. The circumferential location is approximately 180° from the region of Figure 23.

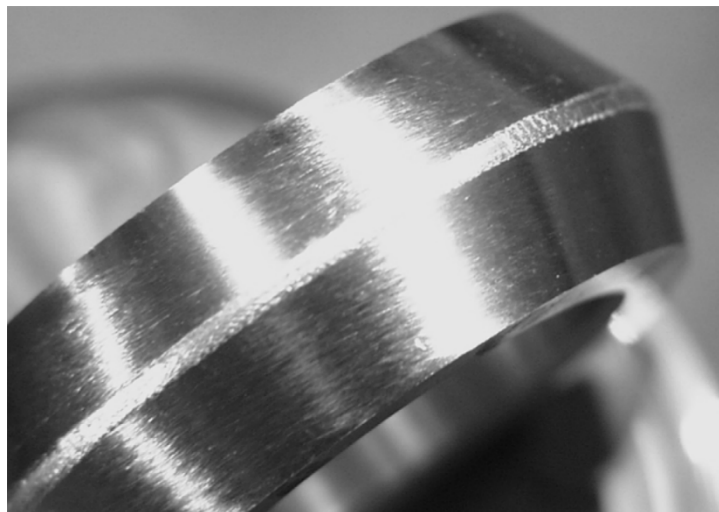
Figure 25.—Condition of the 440C "blend-radius" geometry roller at the end of the damage-initiation test.

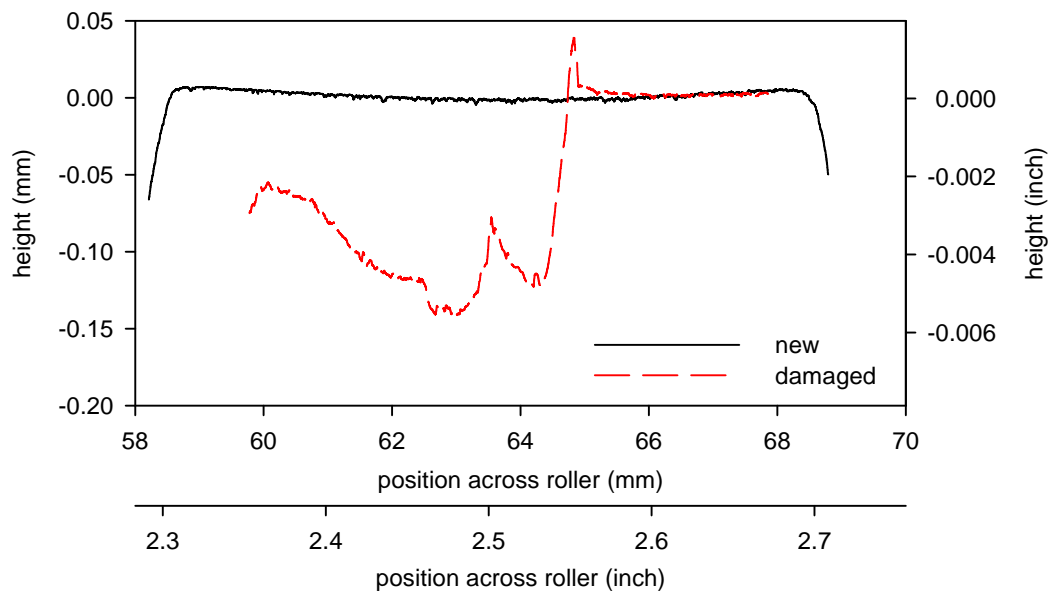
Figure 26.—Profilometer inspections of nitrided 15-5 roller at end of the damage initiation testing, circumferential position #7.

To inspect the depth of the roller damage, a set of stylus profilometer inspections were completed. For the nitrided roller, inspections were made at eight circumferential locations of approximately equal spacing around the periphery. The mating 440C roller had the same appearance about the periphery, and so in this case only three equally spaced circumferential positions were selected for inspection. Results from selected positions will be discussed as follows. The inspection data at the location where the initial chip was liberated (location #7) is provided in Figure 26. The depth of the damage is to approximately tequal to the thickness of the nitrided layer. The inspection data of Figure 27 illustrates the typical damage away from the region of the initial large chip. At this location the depth of the damage is about one-half of the thickness of the nitrided layer. Some plastic flow of material rising above the location of the original surface (new condition) is evident at the edges of the wear track for both locations.

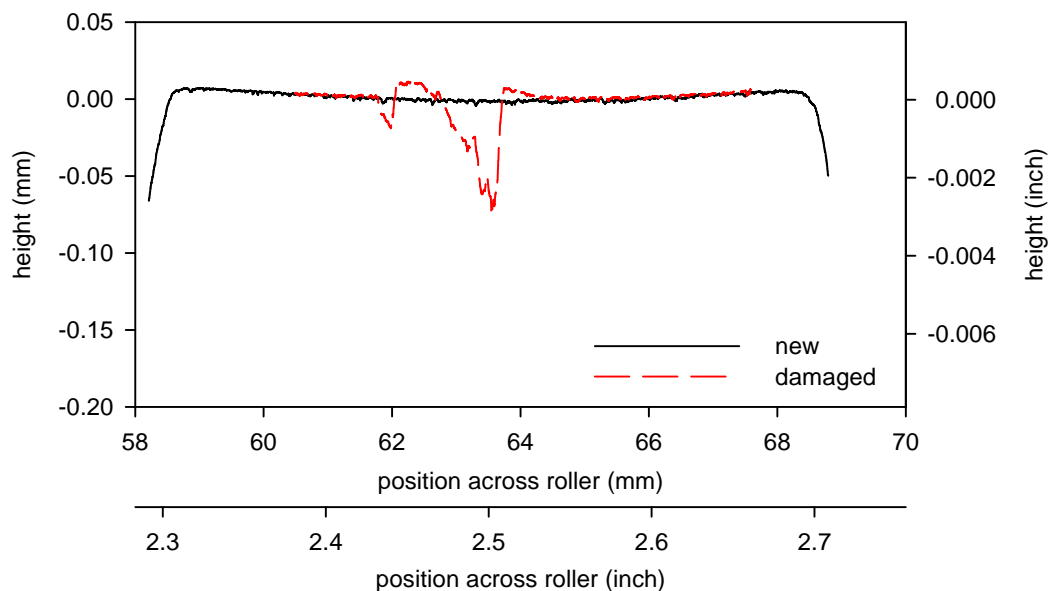
Figure 27.—Profilometer inspections of nitrided 15-5 roller at end of the damage initiation testing, circumferential position #5.

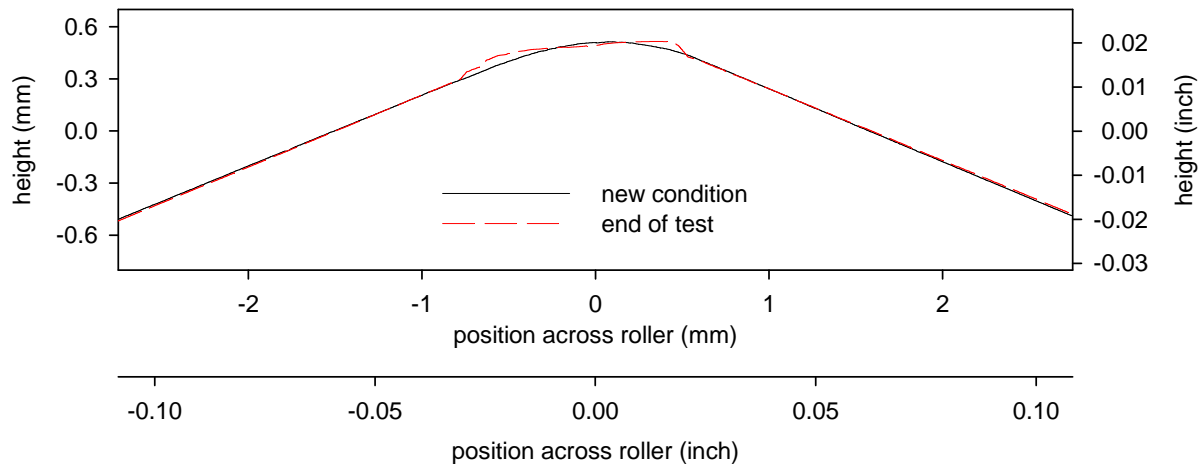
Figure 28.—Profile trace of the blend radius geometry roller when new and after testing, plotted using true aspect ratio to show the shape of the geometry.

The condition of the mating 440C roller with blend-radius geometry at the tip was inspected after the test via the stylus profilometer. The data are presented in Figure 28 using true aspect ratio scaling to show the geometry shape and again in Figure 29 using an expanded ordinate to show details of the condition. From this data it appears that no significant debris was generated from the 440C roller, but significant gross plastic deformation did occur. The axially-directed traction force on the 440C roller was directed toward the right (positive x-direction) relative to the orientation used for inspections of Figures 26 and 27.

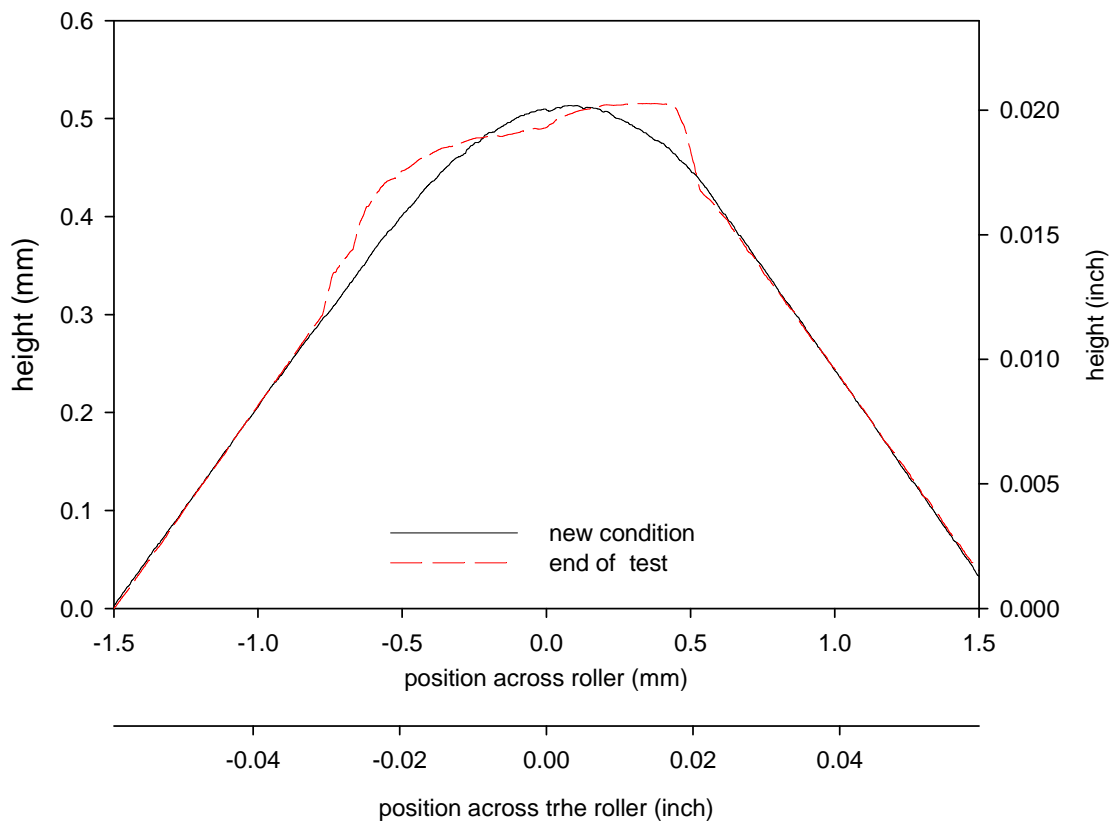
Figure 29.—Profile trace of the blend radius geometry roller when new and after testing, plotted using expanded ordinate scale to show detail.

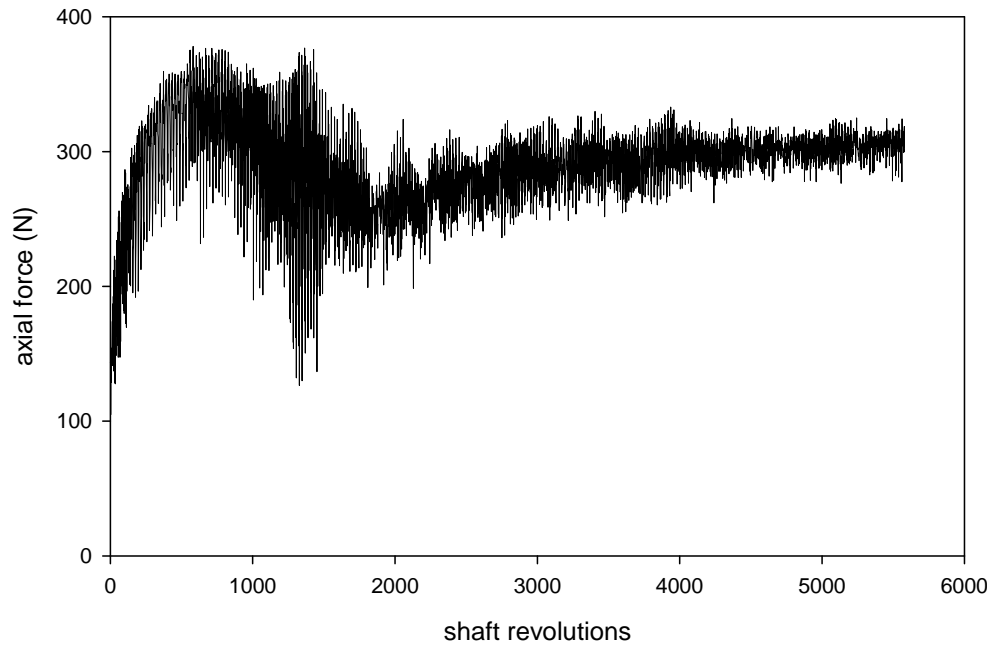
Figure 30.—Trend of the measure axial force as a function of shaft revolutions during the damage propagation testing.

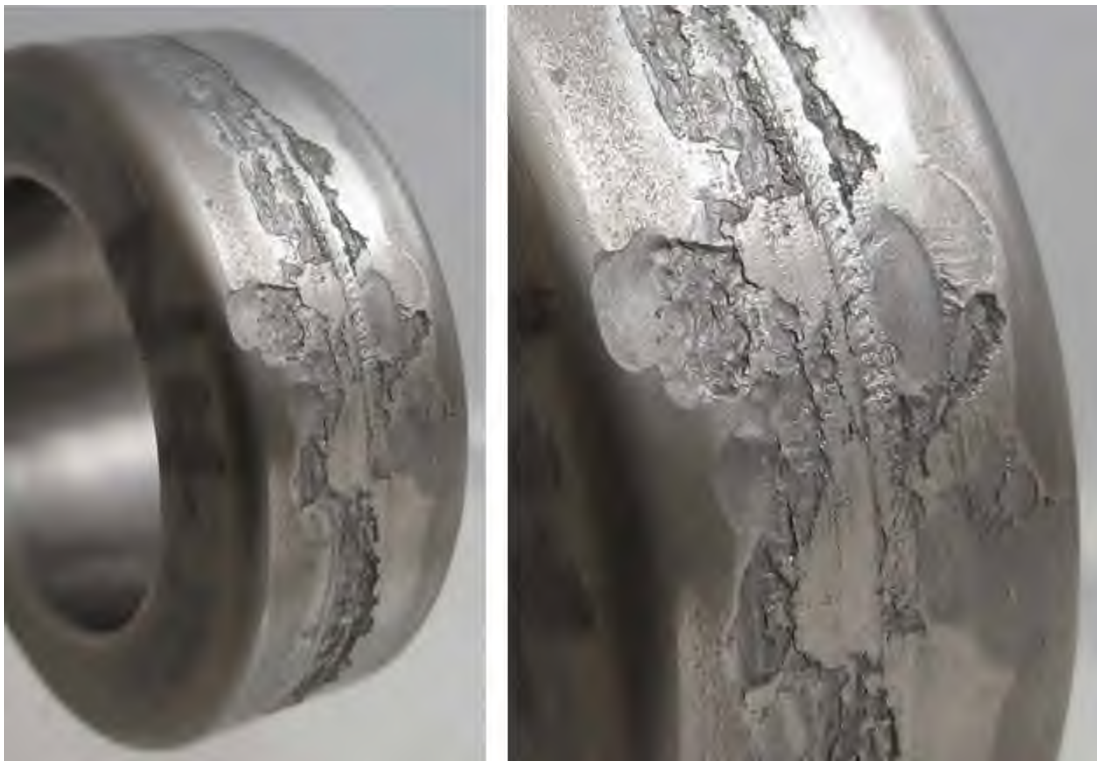
Figure 31.—Condition of the nitrided roller after the damage propagation test, circumferential location 1.

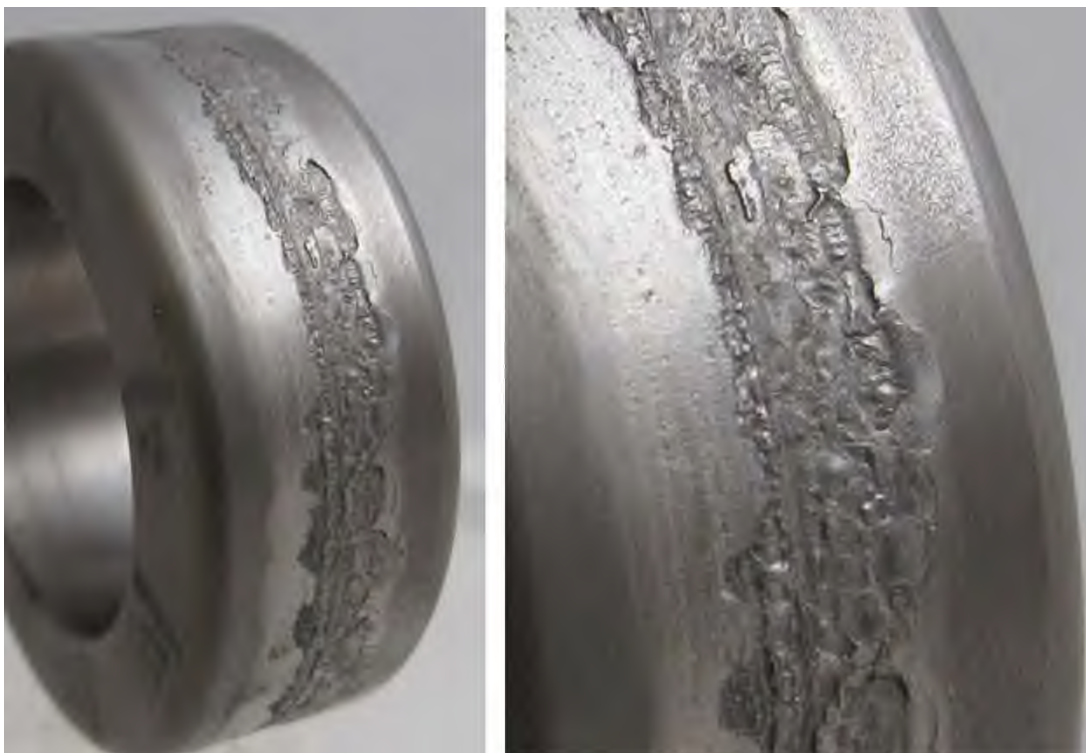
Figure 32.—Condition of the nitrided roller after the damage propagation test, circumferential location 2.
